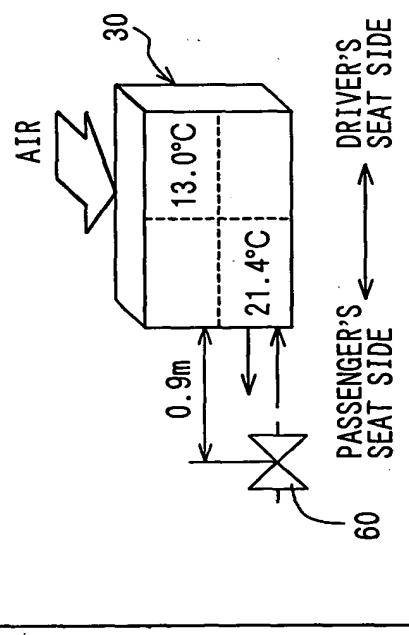
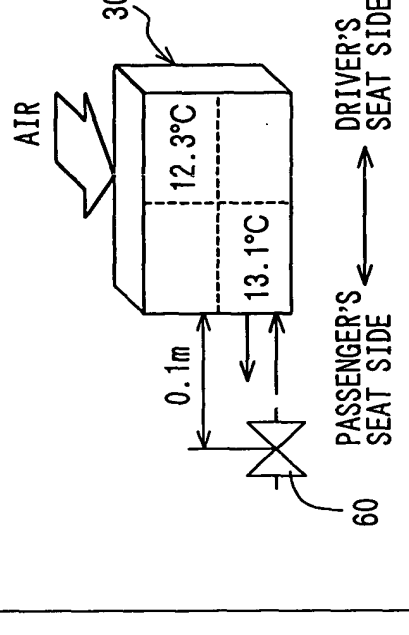
FIG. 6

THROTTLE IS POSITIONED IN ENGINE COMPARTMENT				THROTTLE IS POSITIONED IN VICINITY OF EVAPORATOR			
EVAPORATOR CONDITION	BLOWER INLET TEMPERATURE: 35.1°C EVAPORATOR PRESSURE: 4.7MPa				BLOWER INLET TEMPERATURE: 29.2°C EVAPORATOR PRESSURE: 4.8MPa			
BLOWN AIR TEMPERATURE	PASSENGER'S SEAT SIDE	PASSENGER'S SEAT CENTER	DRIVER'S SEAT CENTER	DRIVER'S SEAT SIDE	PASSENGER'S SEAT SIDE	PASSENGER'S SEAT CENTER	DRIVER'S SEAT CENTER	DRIVER'S SEAT SIDE
	<u>21.1°C</u>	19.2°C	<u>17.7°C</u>	17.9°C	15.2°C	14.6°C	<u>14.0°C</u>	<u>15.5°C</u>
POST-EVAPORATOR AIR TEMPERATURE
